Grove Street Outfall Project Improves Drainage Using Concrete Pipe

By Douglas J. Holdener, P.E. Florida Region Engineer Rinker Materials Concrete Pipe Division – CEMEX dholdener@cemexusa.com

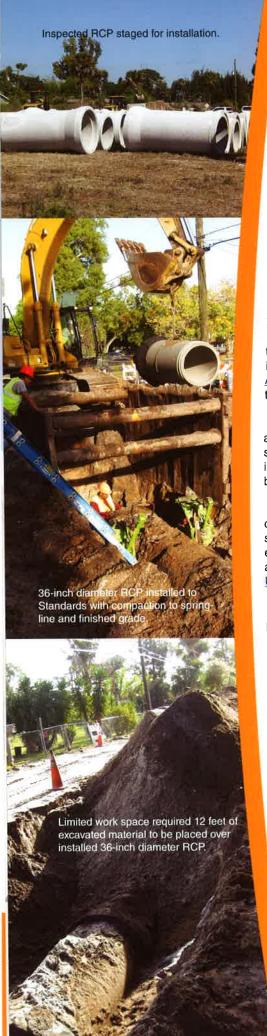
Photos: Douglas J. Holdener, P.E.

During construction of the sewer, Evans Street remained open to allow residential property access by restricting the two-lane roadway to a single lane. Limited right-of-way restricted the work space and storage of excavated material. Therefore, excavated fill was piled atop the storm pipe installation as the pipe was installed. Consequently, approximately 10 to 12 feet of temporary embankment was loaded over 36-inch diameter concrete pipe.

Centerline Utilities performed a "textbook' installation of the RCP by properly compacting the pipe's bedding and backfill up to the haunches. Incidentally, compaction and backfill above the springline has a negligible effect on the structural performance of RCP. While the temporary staging of excavated material over the installed pipeline may have potentially damaged a flexible pipe⁸, the contractor trusted it would not harm the concrete pipe system. The investment in RCP ensures a long-term value to Palm Beach County, the Town of Haverhill, and the residents and businesses of the community.
